# Locations Identified Contain Deteriorated Lead Based Paint On The A Side Of The Building

# PHOTOS OF COMPONENTS WHICH CONTAIN LEAD AT 300 EAST WASHINGTON BOULEVARD, LOS ANGELES, CA

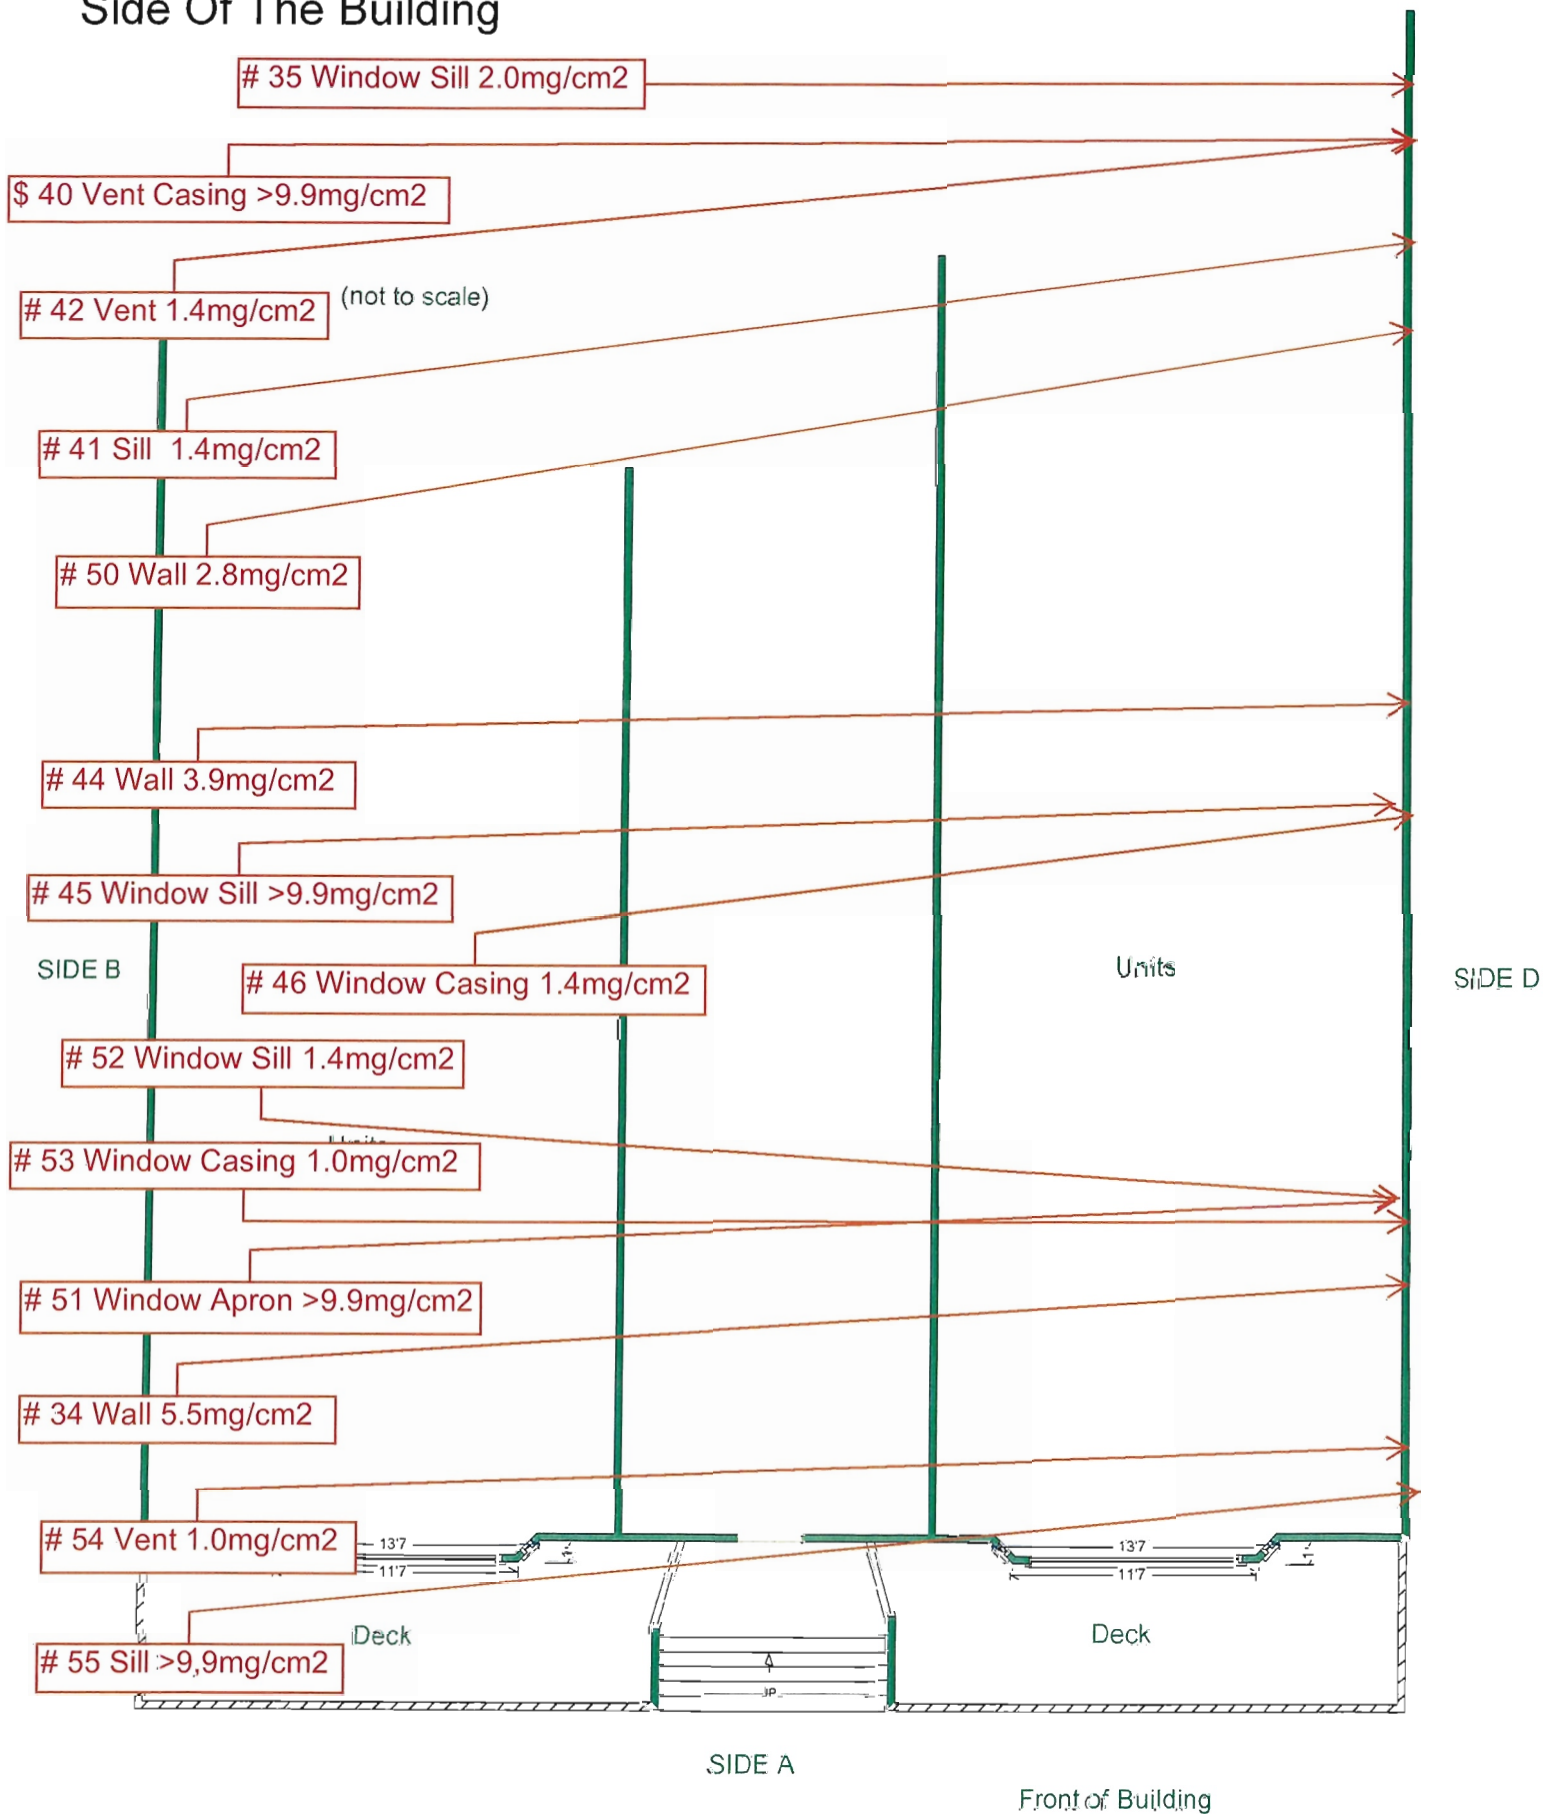
# Locations Identified Contain Deteriorated Lead Based Paint On The D Side Of The Building

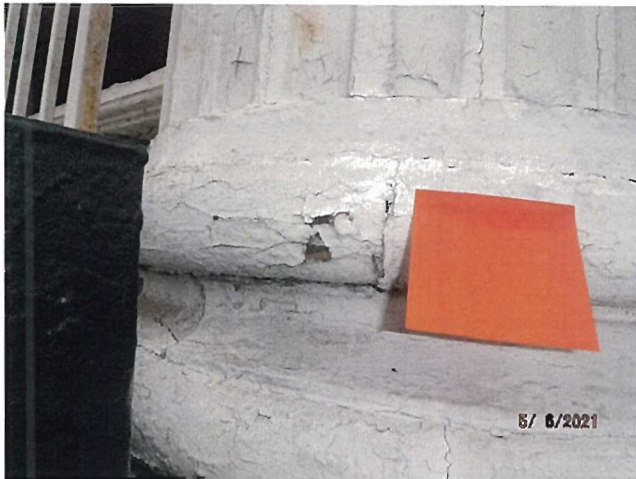
PHOTO # 1  
# 5 A,R Column

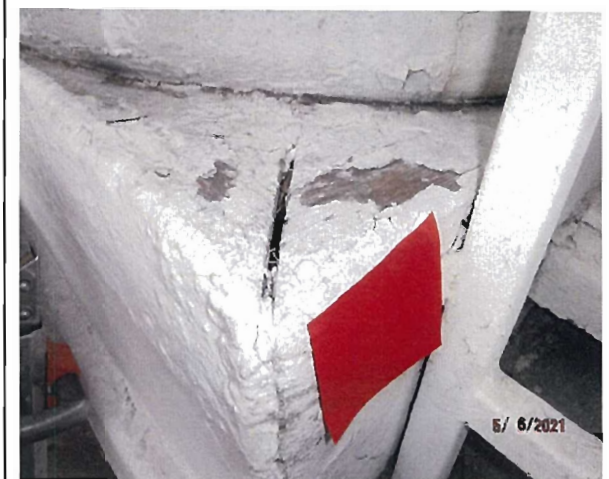
PHOTO # 3  
# 8 A,C Column

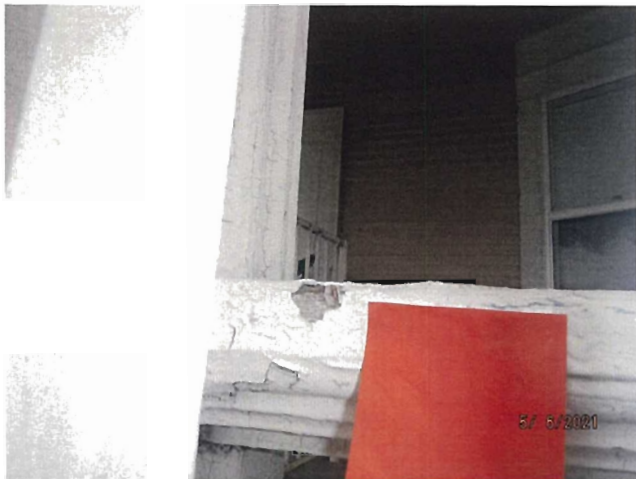
PHOTO # 4  
# 9 A,R Handrail

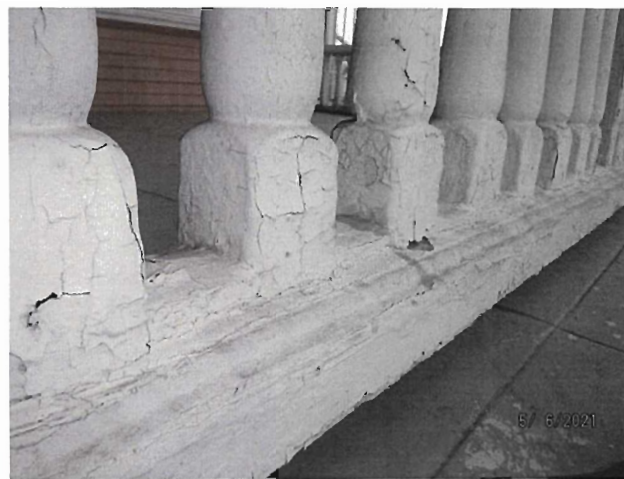
PHOTO # 5  
# 9 A,R Handrail

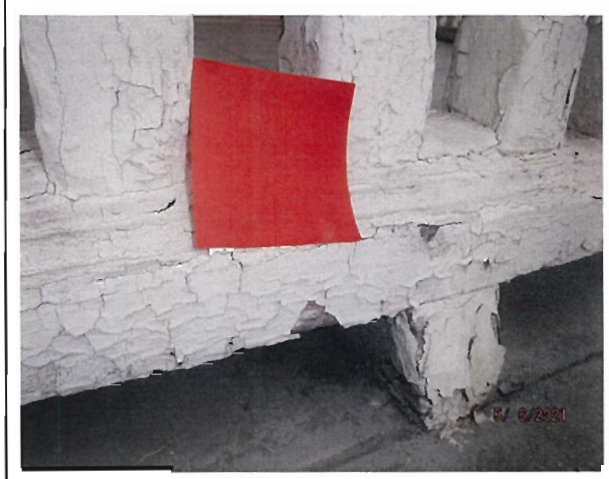
PHOTO # 6  
# 9 A,R Handrail

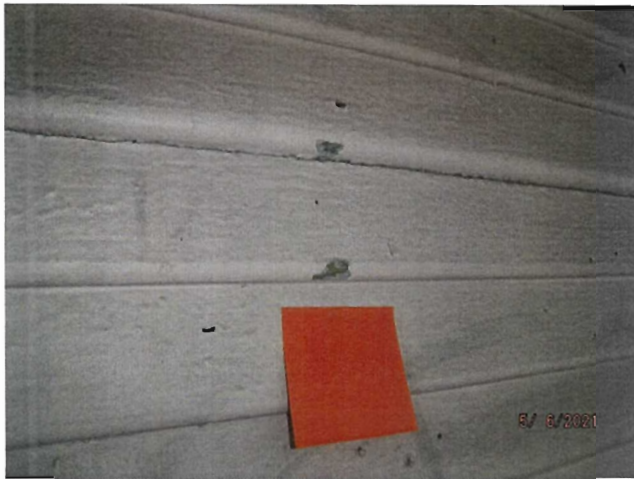
PHOTO # 7  
# 14 A,R Wood Wall

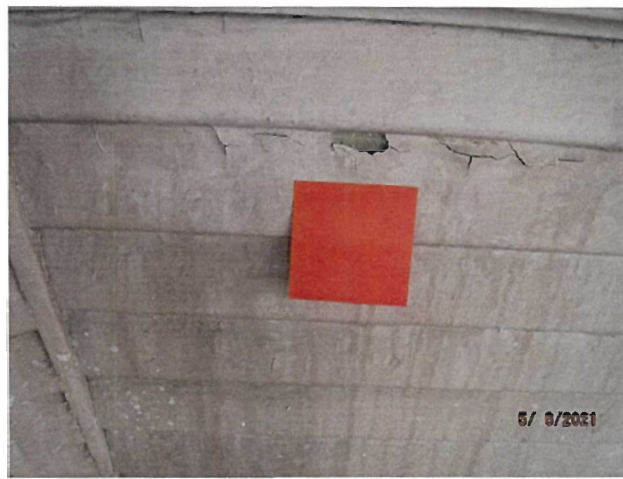
PHOTO # 8  
# 14 A,R Wood Wall

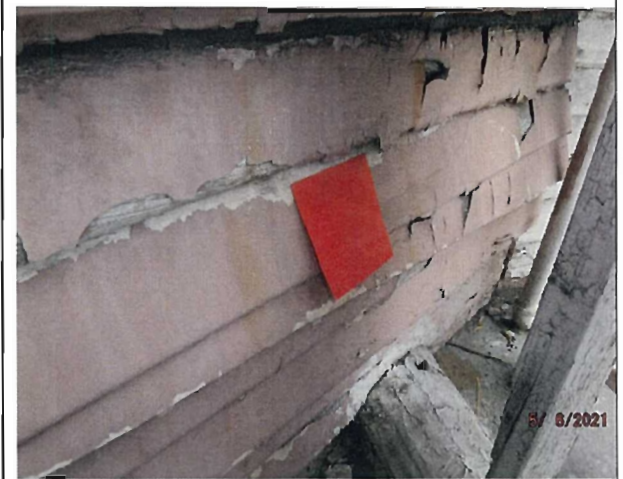
PHOTO # 9  
# 14 A,R Wood Wall

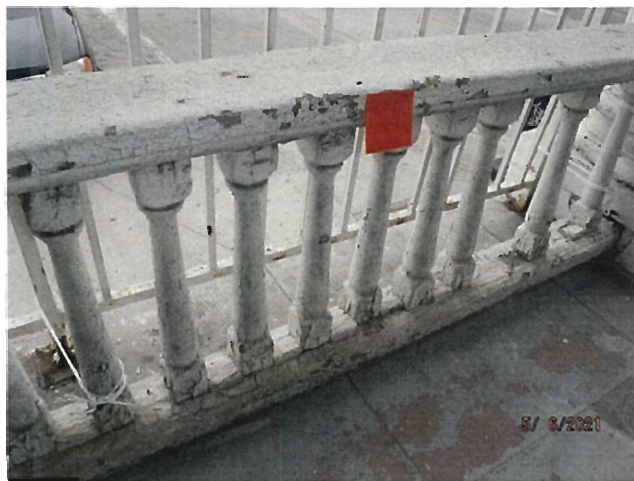
PHOTO # 10  
# 16 A,R Wall Cap

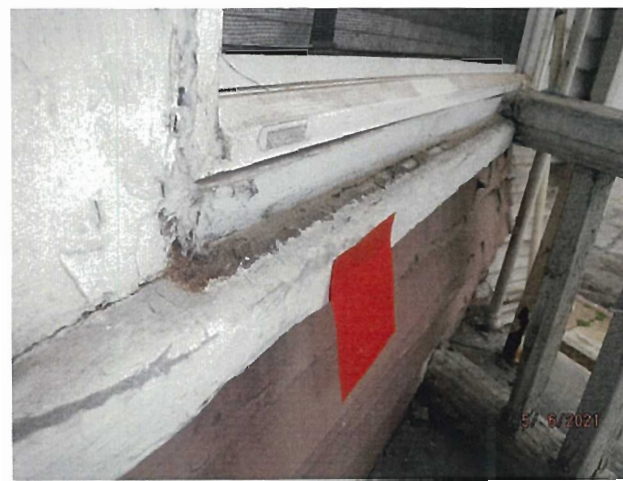
PHOTO # 11  
# 17 A,R Window Sill

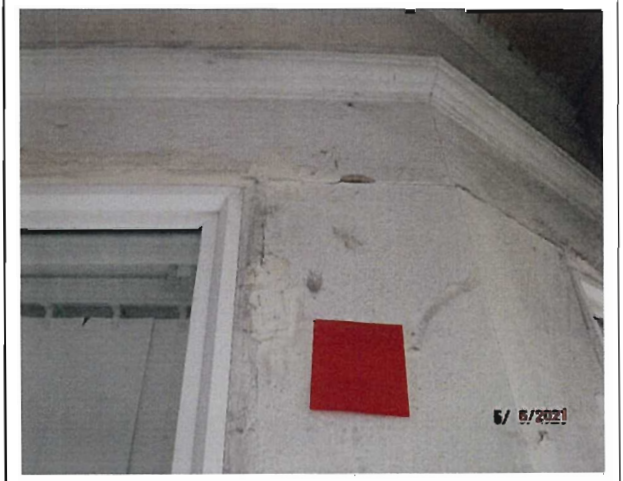
PHOTO # 12  
# 18 A,R Window Casing

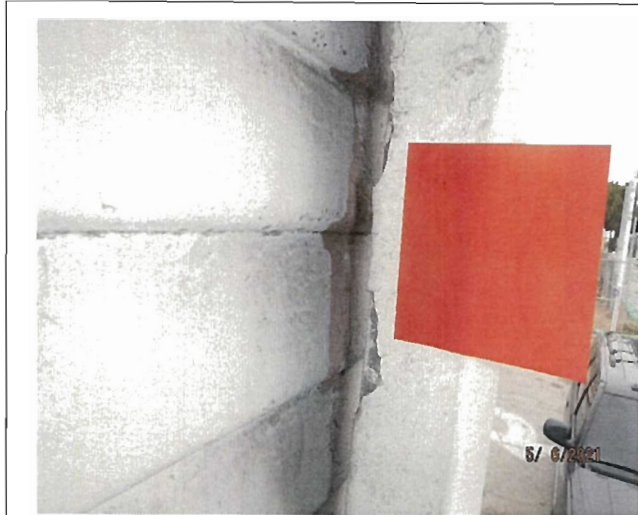
PHOTO # 13  
# 15 A,R Downspout

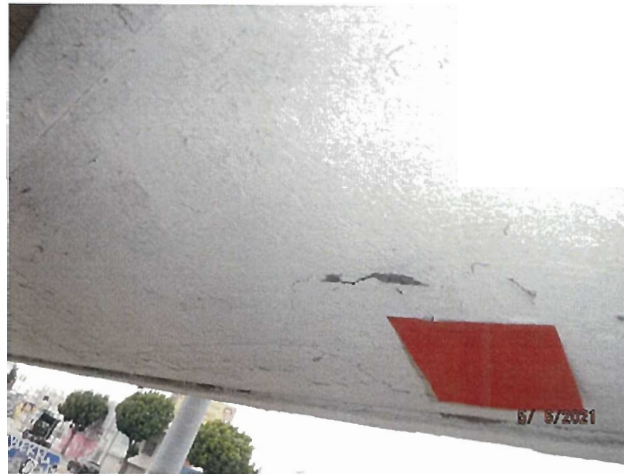
PHOTO # 14  
# 19 A,R Header

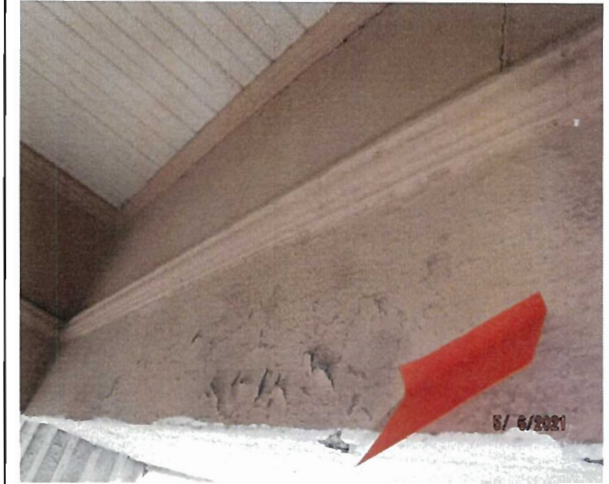
PHOTO # 15  
# 20 A,R Header

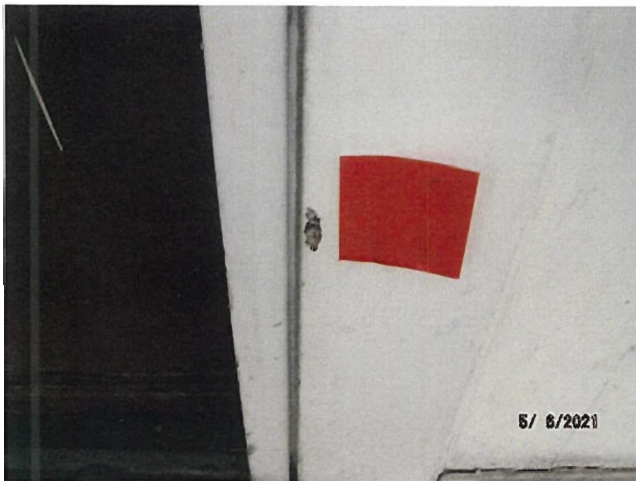
PHOTO # 16  
# 22 A,C Wood Casing

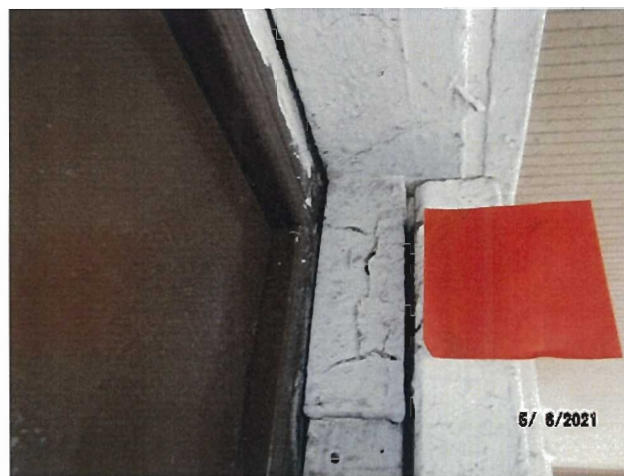
PHOTO # 17  
# 23 A,C Wood Jamb

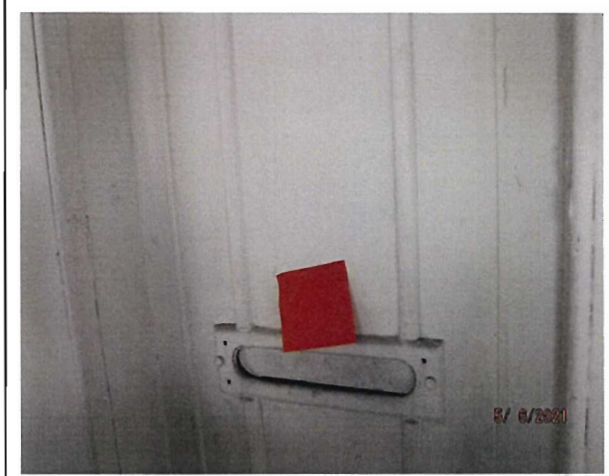
PHOTO # 18  
# 24 A,C Panel

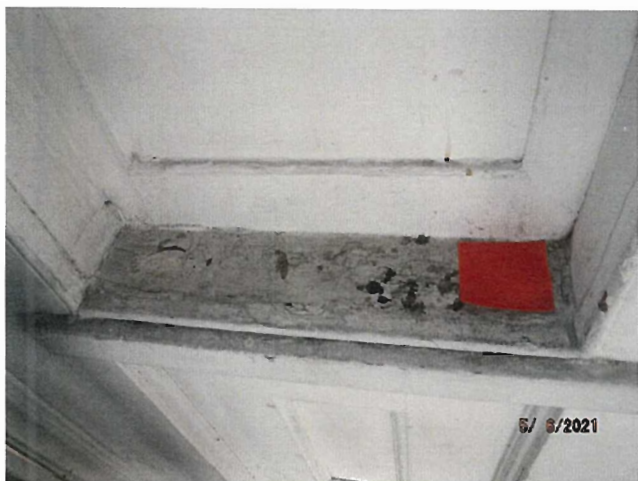
PHOTO # 19  
# 25 A,C Panel Sill

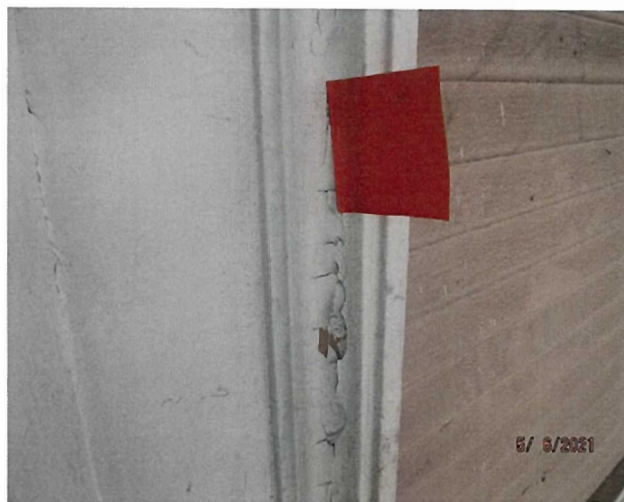
PHOTO # 20  
# 26 A,C Entry Casing

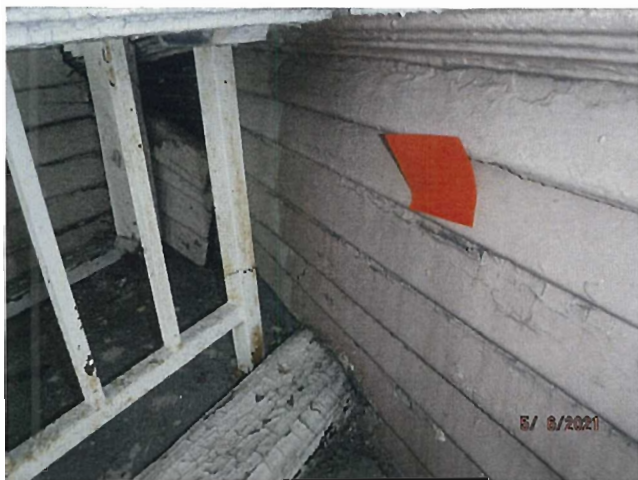
PHOTO # 22  
# 28 A,L Wood Wall

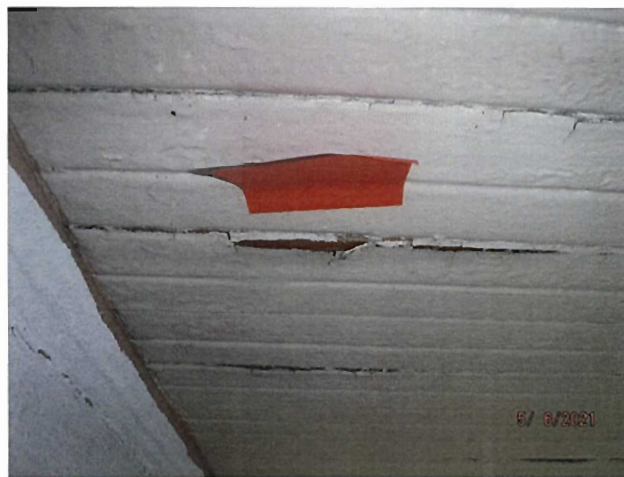
PHOTO # 23  
# 29 A,L Soffit

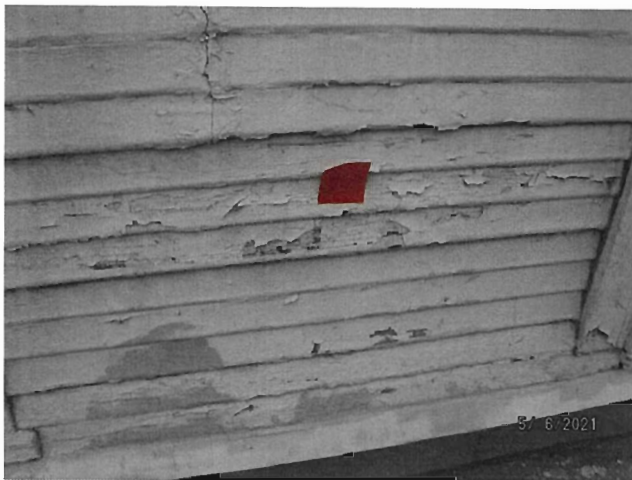
PHOTO # 25  
# 34 D,R Wood Wall

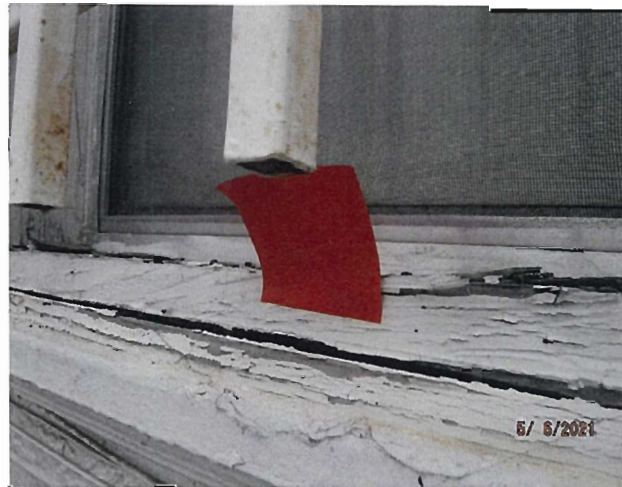
PHOTO # 26  
# 35 D,R Window Sill

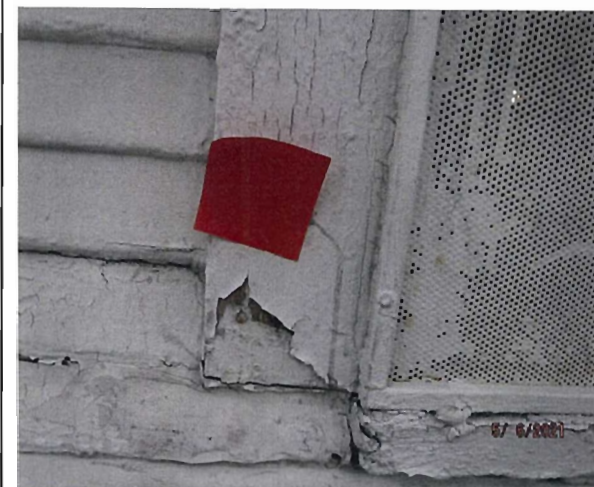
PHOTO # 27  
# 40 D,R Vent Casing

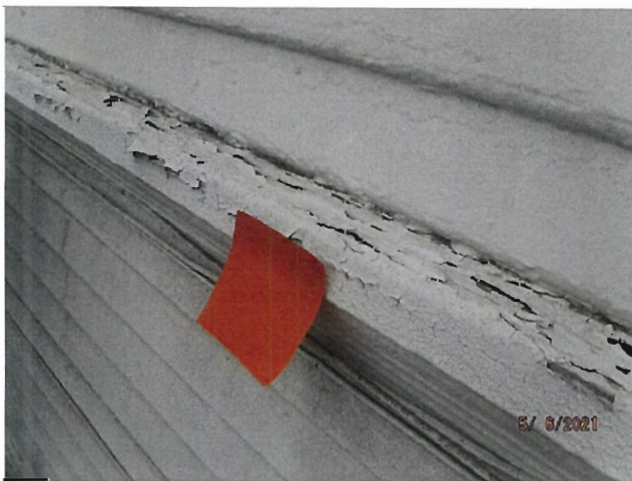
PHOTO # 28  
# 41 D,R Sill

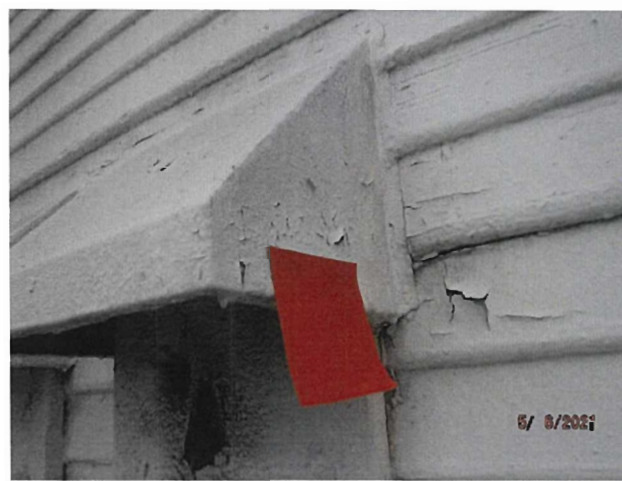
PHOTO # 29  
# 42 D,R Vent

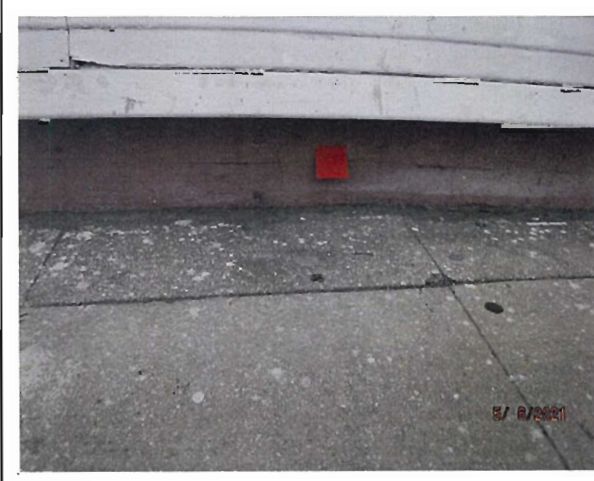
PHOTO # 30  
# 43 D,R Foundation

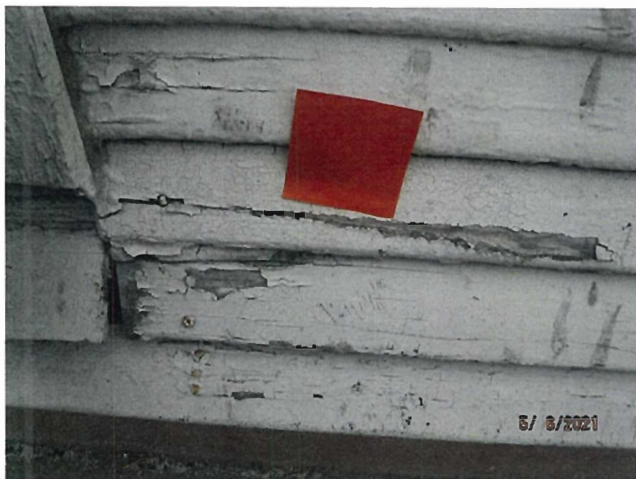
PHOTO # 31  
# 44 D,C Wood Wall

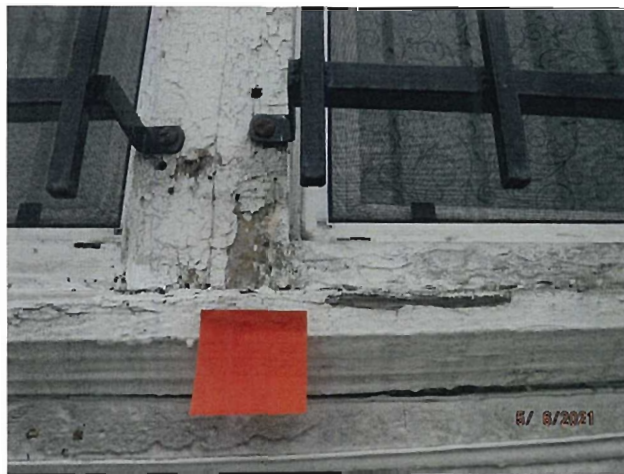
PHOTO # 32  
# 45 D,C Window Sill

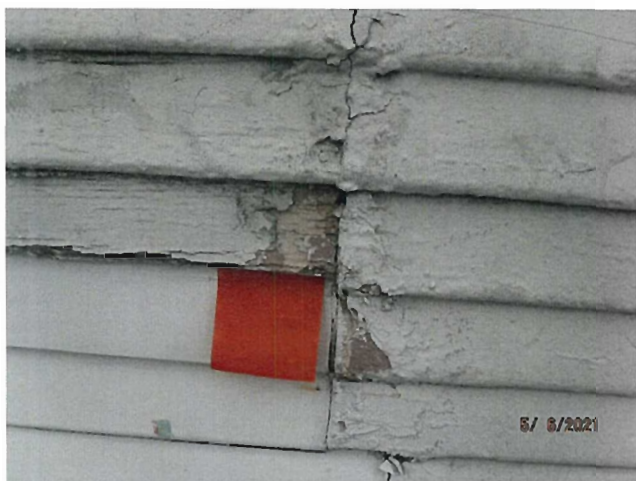
PHOTO # 34  
# 50 D,L Wood Wall

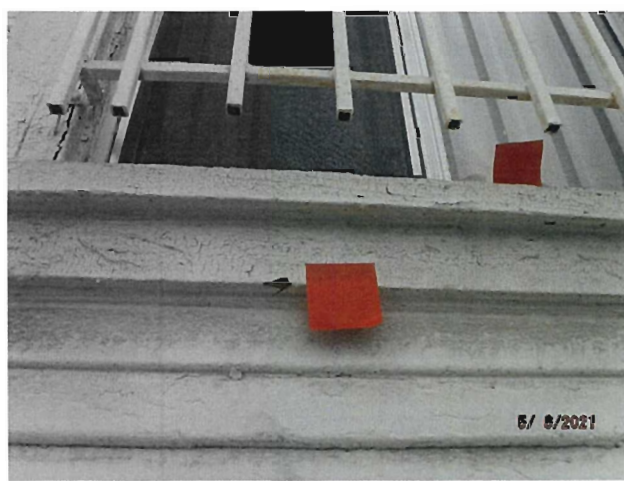
PHOTO # 35  
# 51 D,L Window Apron

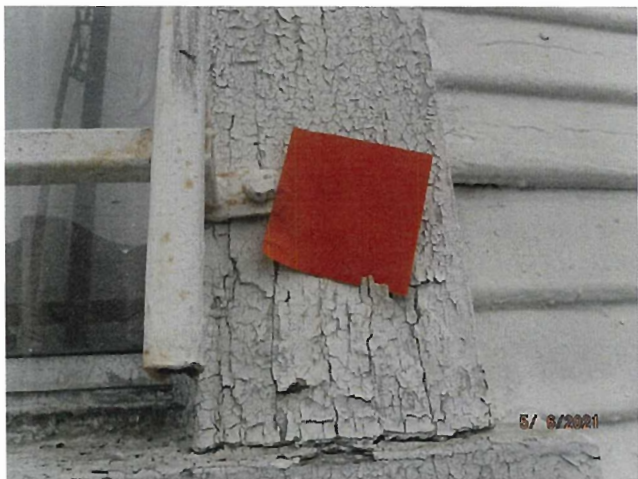
PHOTO # 37  
# 53 D,L Window Casing

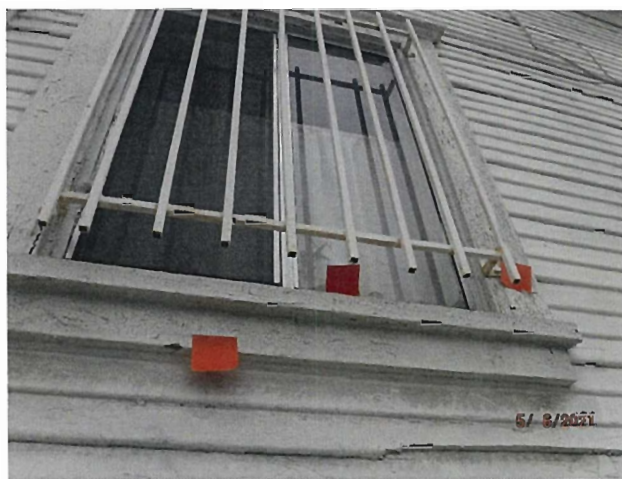
PHOTO # 38  
# 51, 52, 53 D,L Window Components

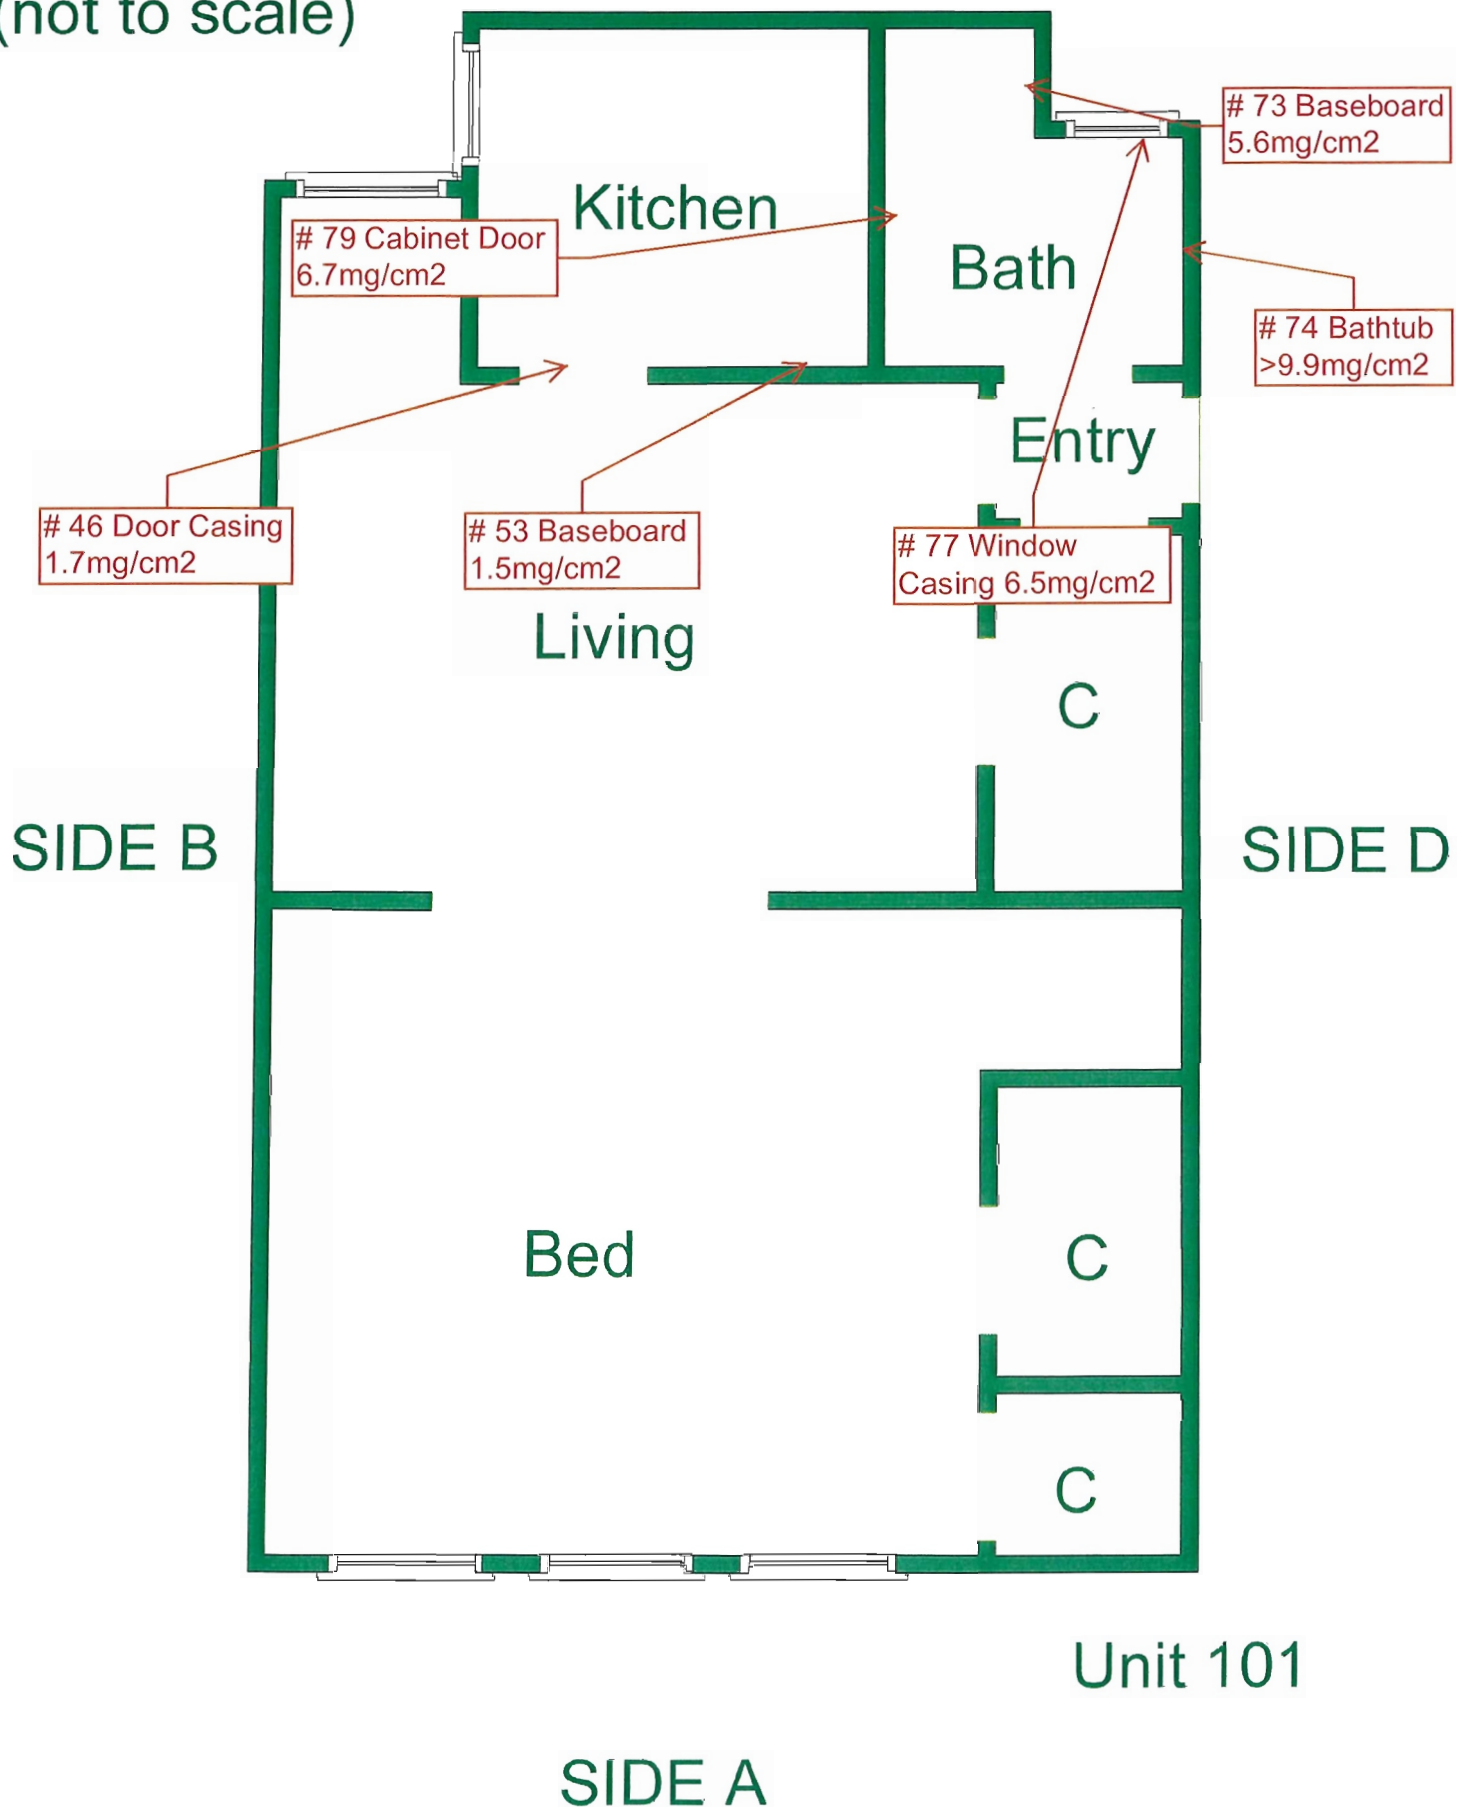
## SIDE C

Locations Identified Contain Deteriorated Lead Based Paint  
(not to scale)

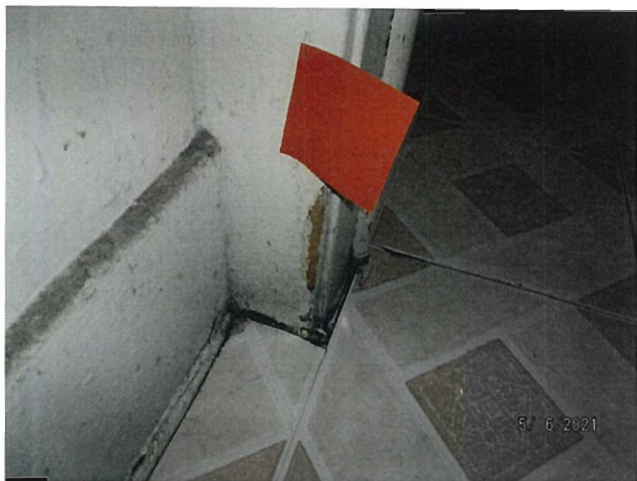
PHOTO # 1  
# 46 A,C Kitchen Door Casing

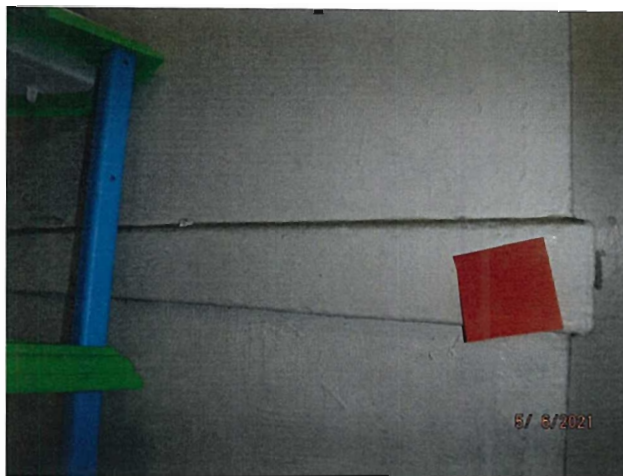
PHOTO # 2  
# 52 A,L Kitchen Chair Rail

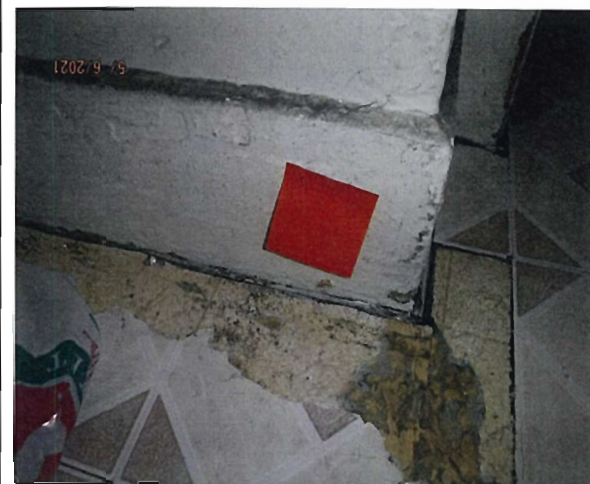
PHOTO # 3  
# 53 A,L Kitchen Baseboard

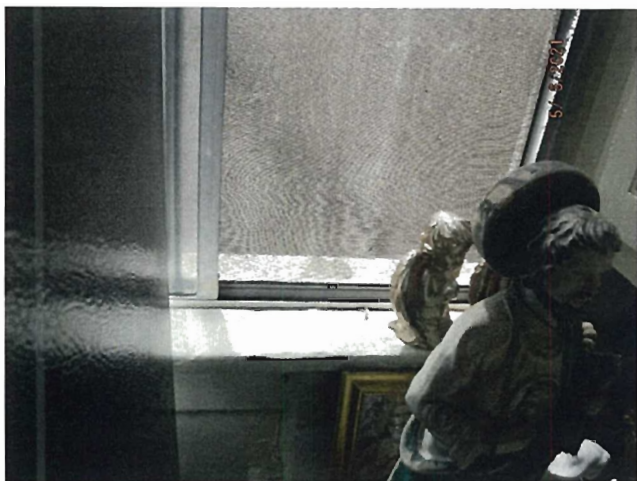
PHOTO # 4  
# 55 B,R Kitchen Window Sill

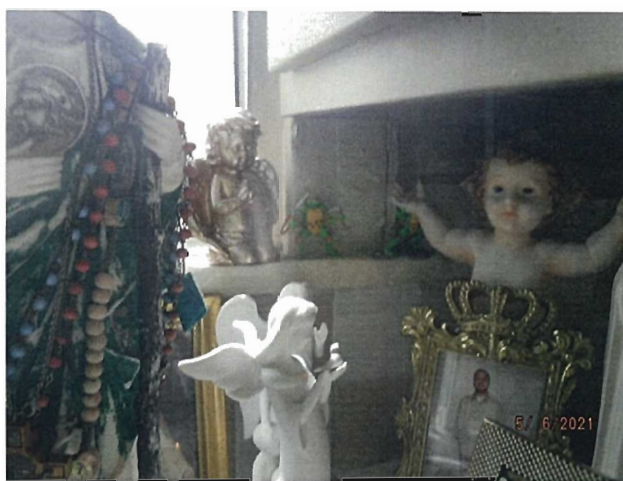
PHOTO # 5  
# 56 B,R Kitchen Window Casing

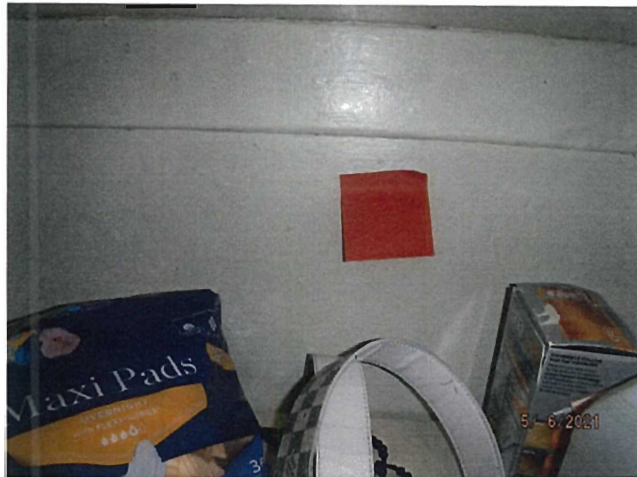
PHOTO # 7  
# 71 C,L Bath Wall

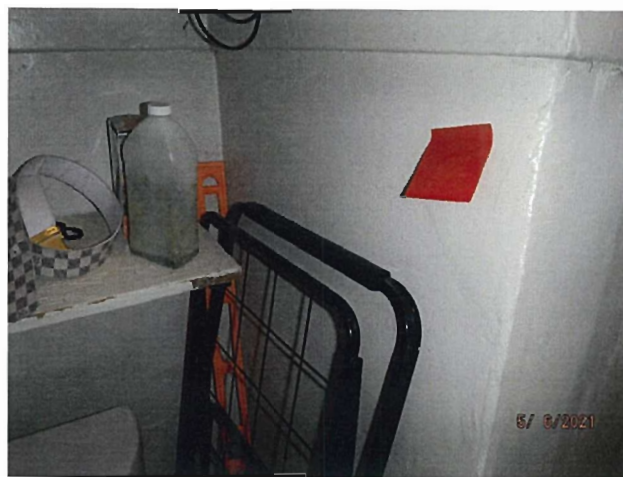
PHOTO # 8  
# 72 C,L Bath Wall

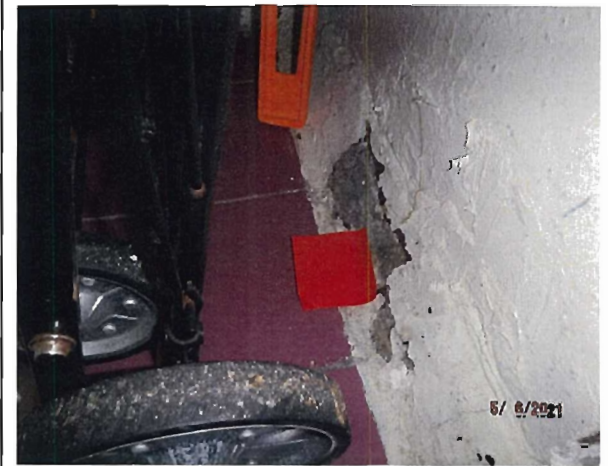
PHOTO # 9  
# 73 D,L Bath Baseboard

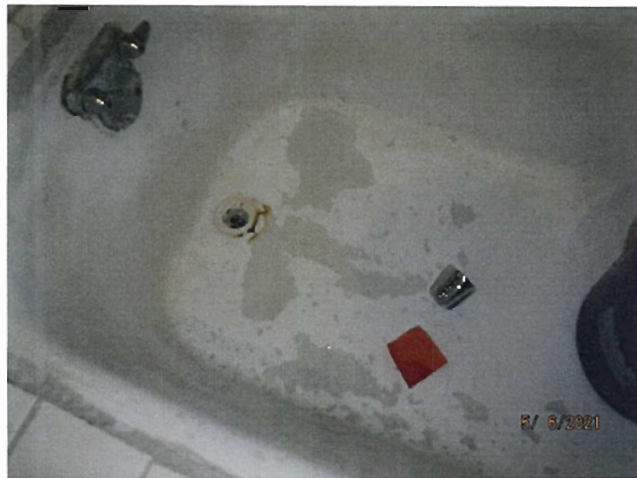
PHOTO # 10  
# 74 D,C Bath Bathtub

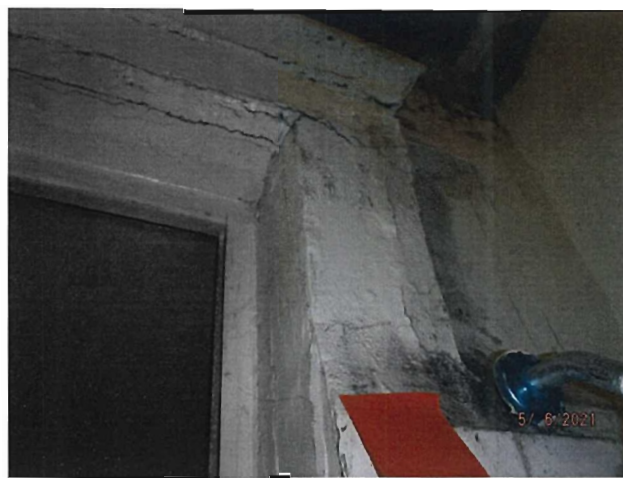
PHOTO # 11  
# 77 C,R Bath Window Casing

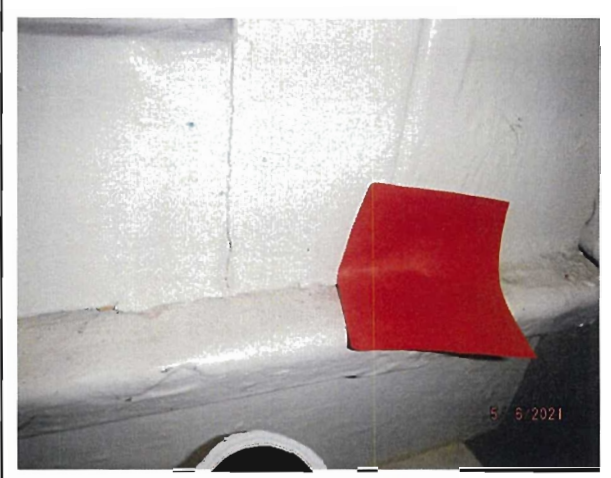
PHOTO # 12  
# 79 B,C Bath Cabinet door and Shelf

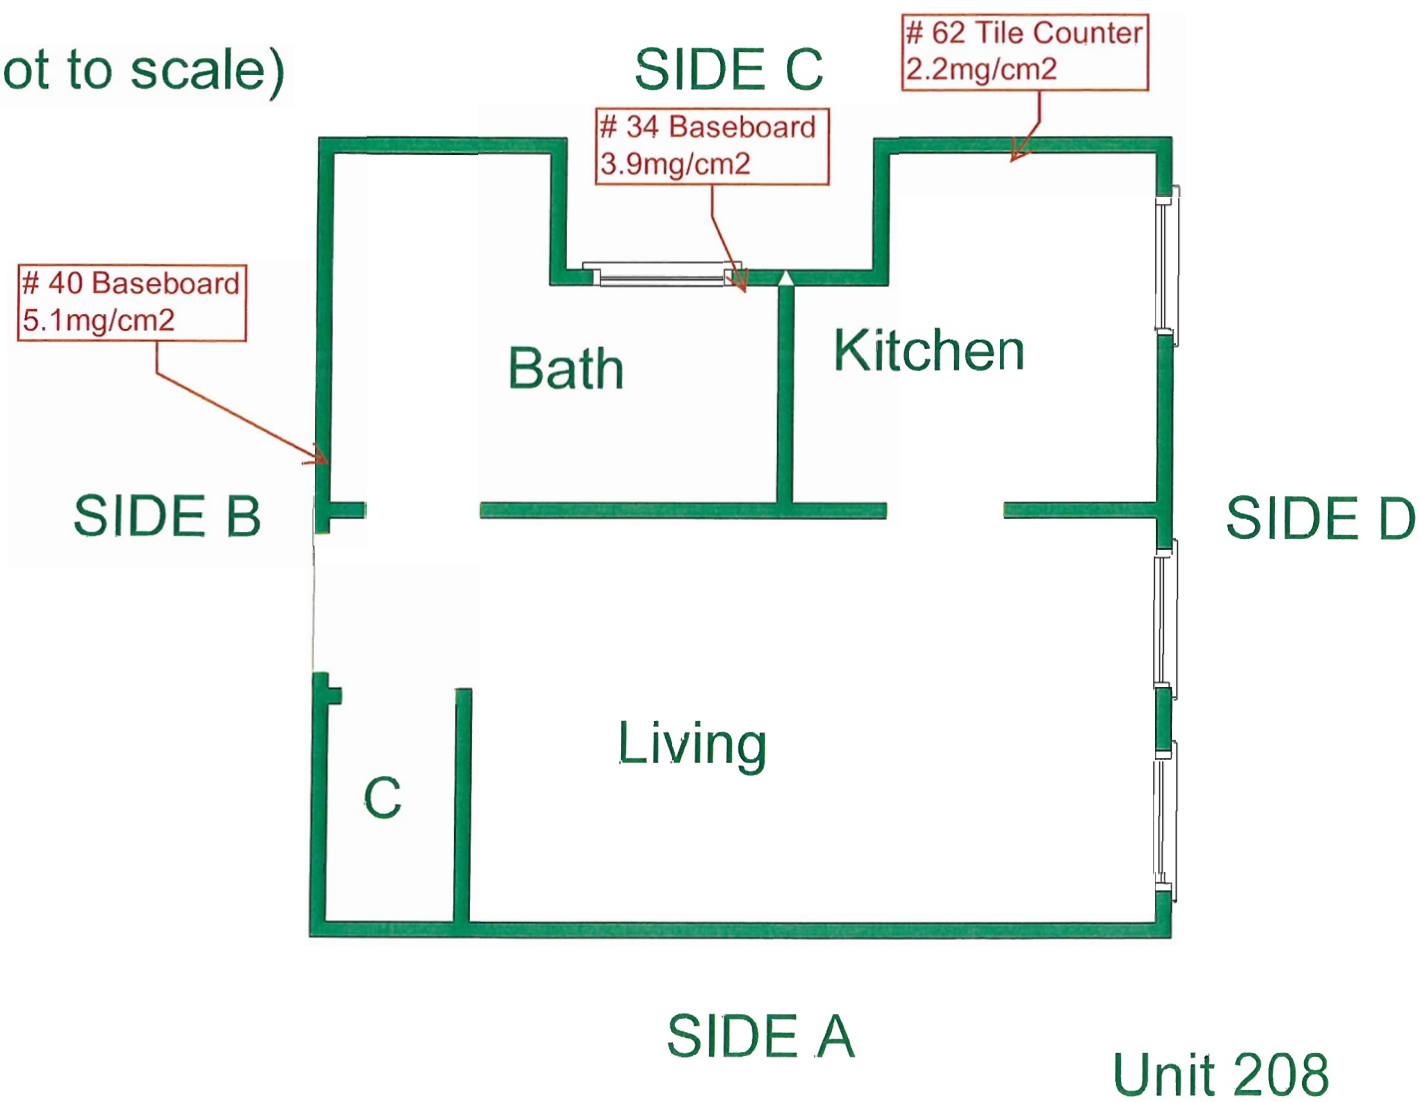
## Locations Identified Contain Deteriorated Lead Based Paint

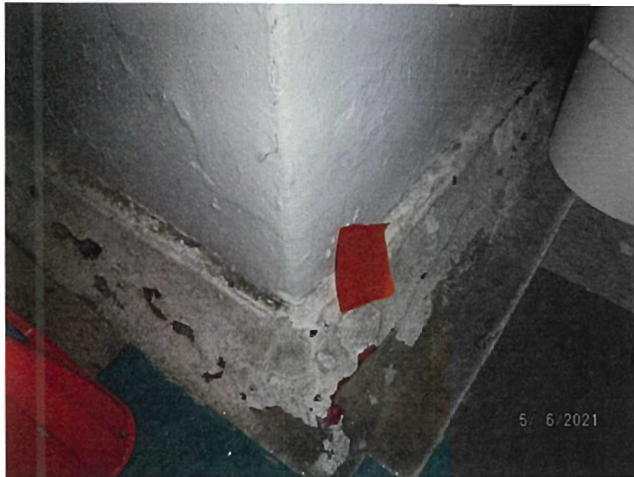
PHOTO # 1  
# 34 C,R Bath Baseboard

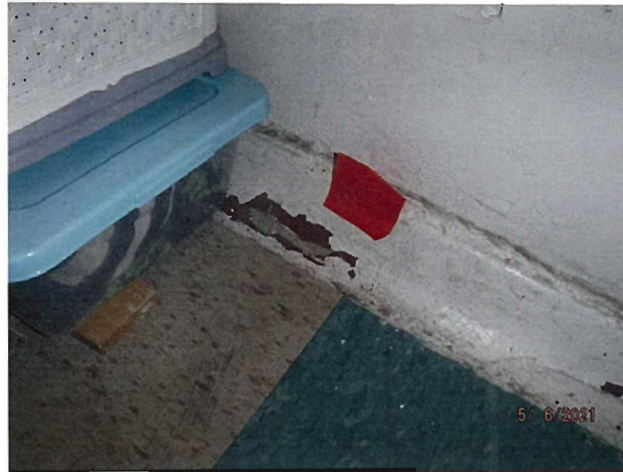
PHOTO # 2  
# 40 B,L Bath Baseboard

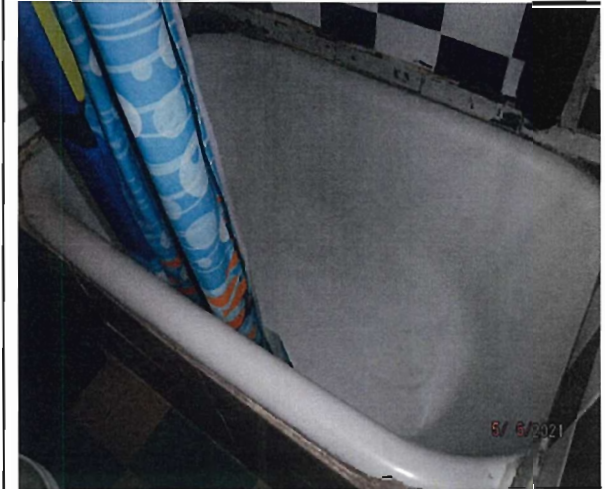
PHOTO # 3  
# 45 A,L Bath Bathtub

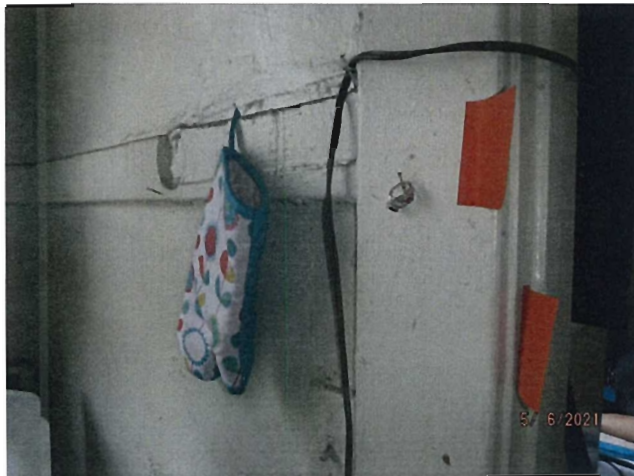
PHOTO # 4  
# 48, 49 A,C Kitchen Door Casing and Jamb

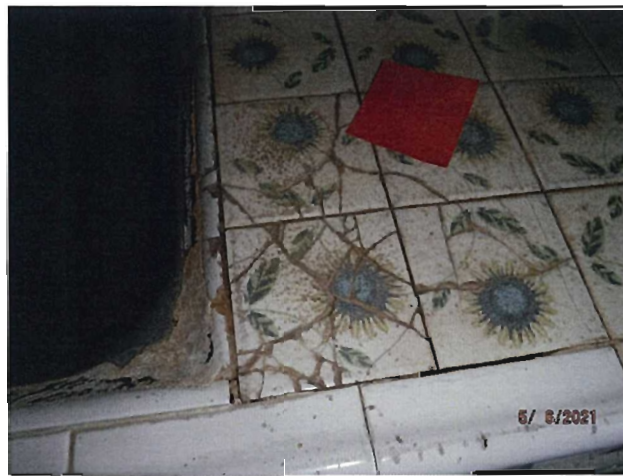
PHOTO # 5  
# 62 C,C Kitchen Tile Counter

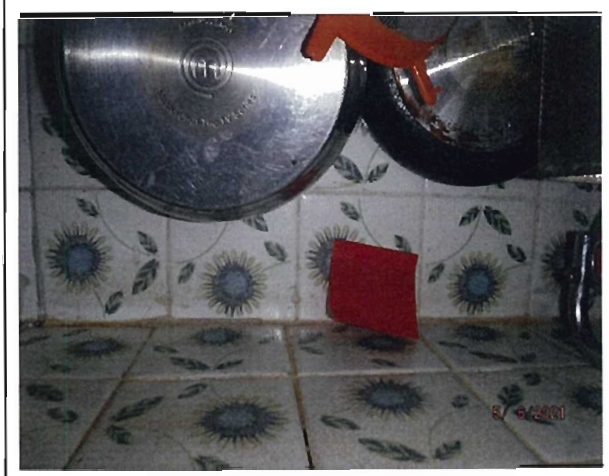
PHOTO # 6  
# 63 C,C Kitchen Backsplash
