# Locations Identified Contain Deteriorated Lead Based Paint On The A Side Of The Building

# PHOTOS OF COMPONENTS WHICH CONTAIN LEAD AT 300 EAST WASHINGTON BOULEVARD, LOS ANGELES, CA

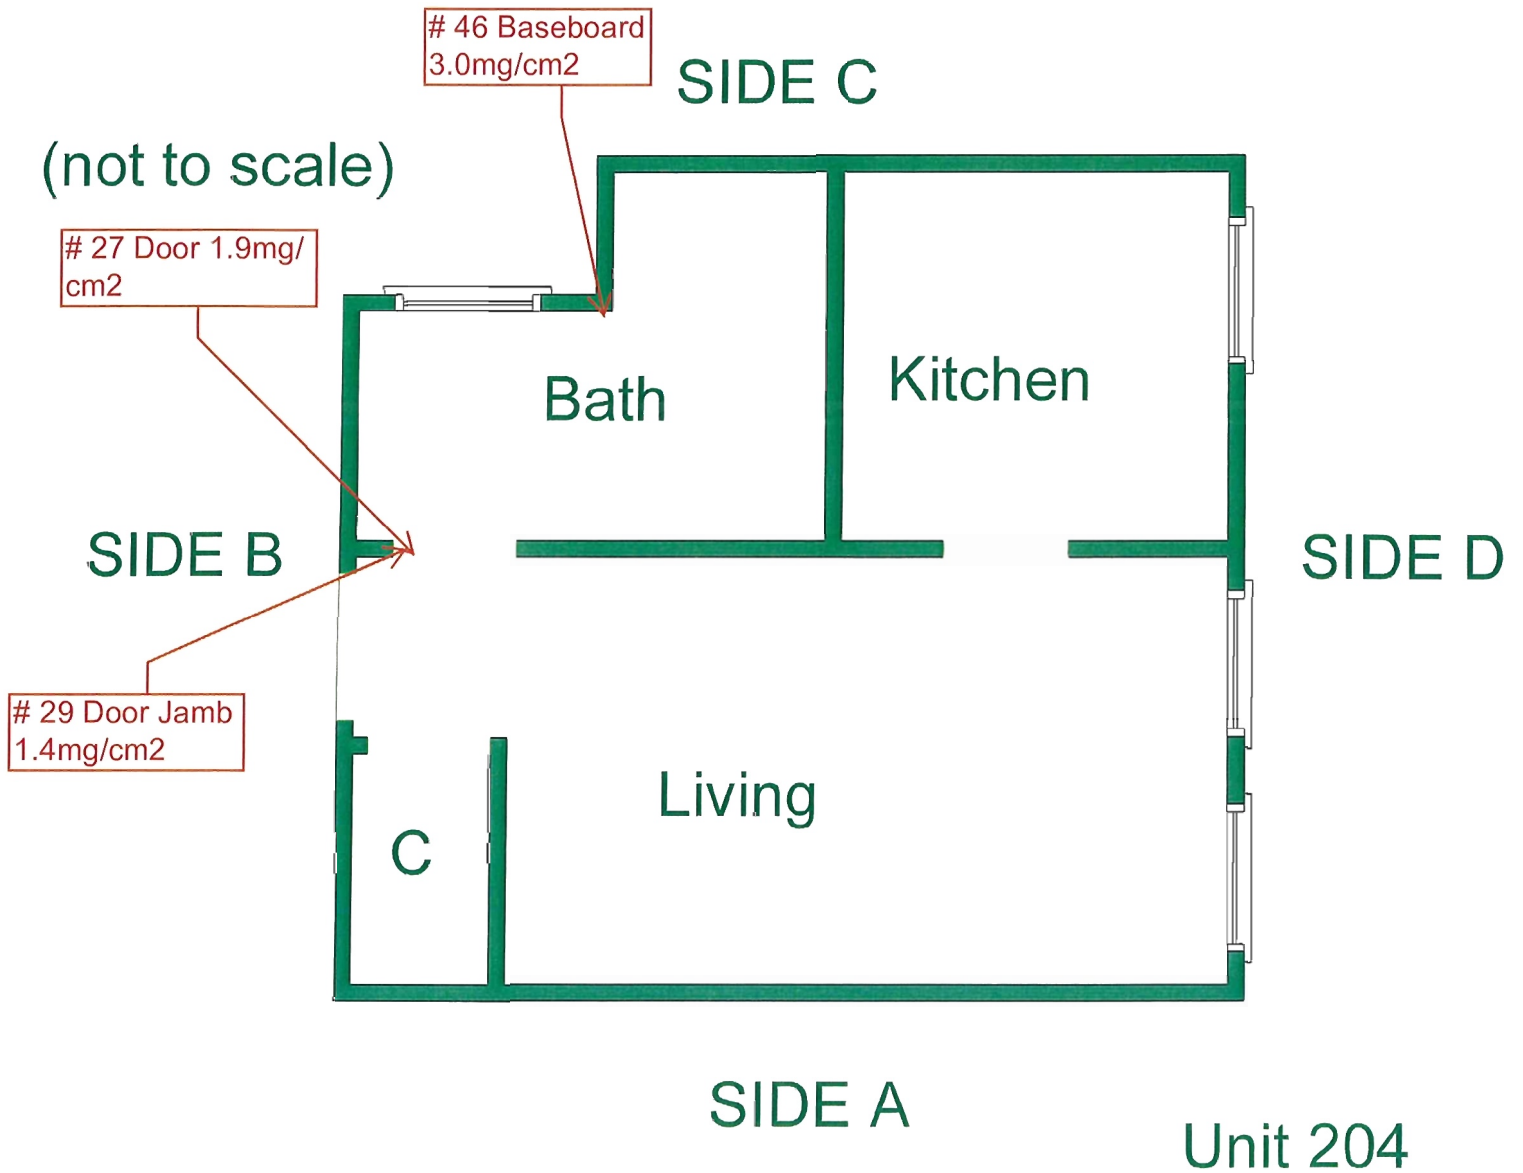
## Locations Identified Contain Deteriorated Lead Based Paint

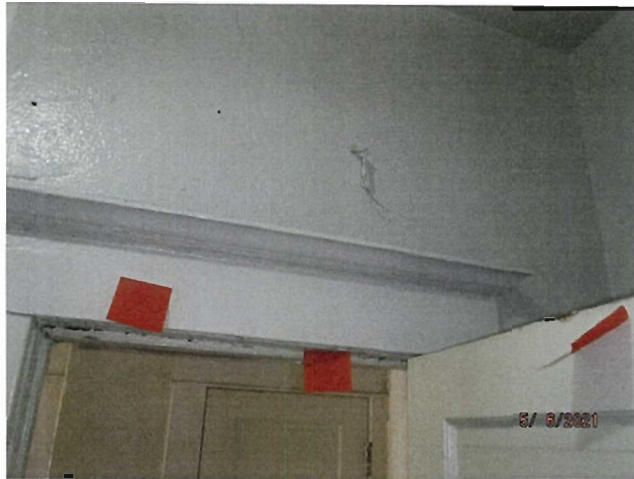
PHOTO # 1  
# 27, 28, 29 A,R Bath Door, Casing and Jamb

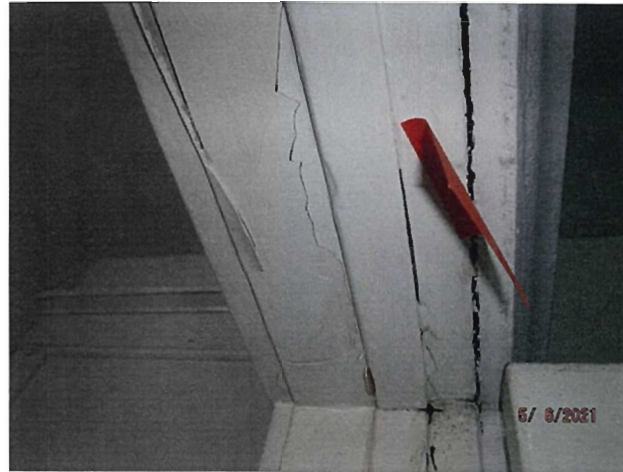
PHOTO # 2  
# 29 A,R Bath Door Jamb

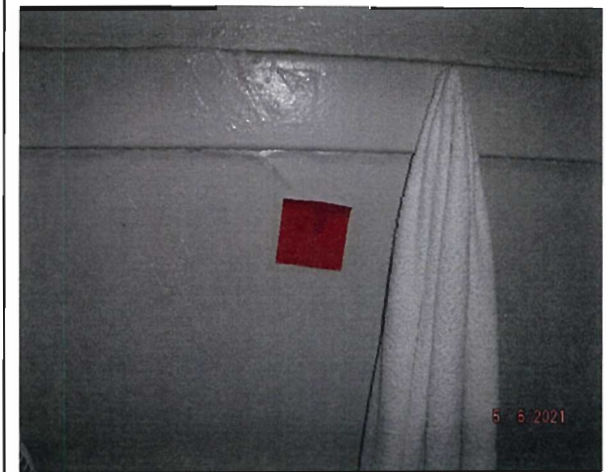
PHOTO # 3  
# 31 B,C Bath Wall

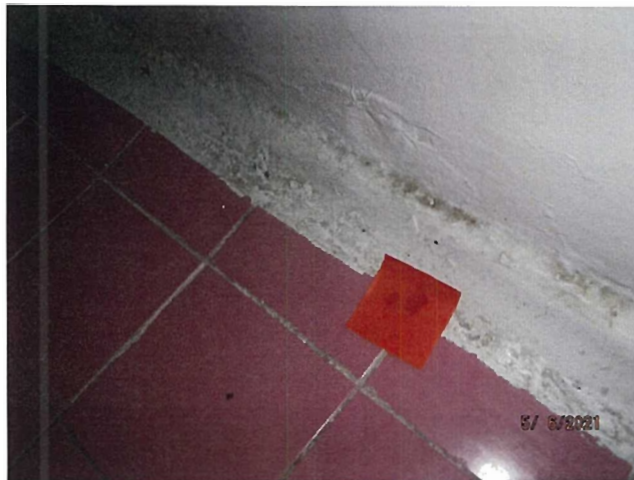
PHOTO # 4  
# 34 C,C Bath Baseboard

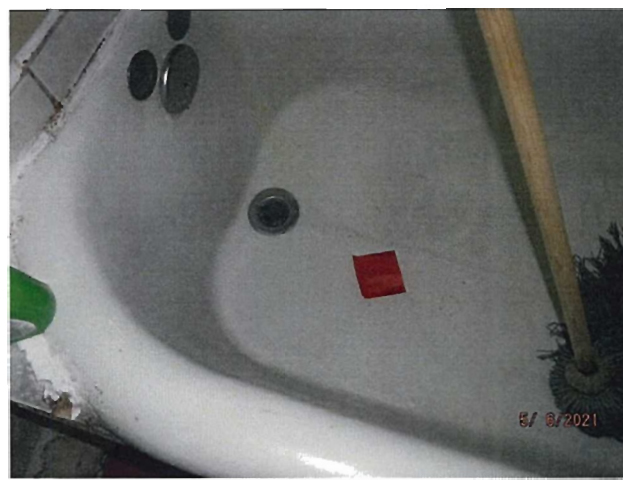
PHOTO # 5  
# 38 A,L Bath Bathtub

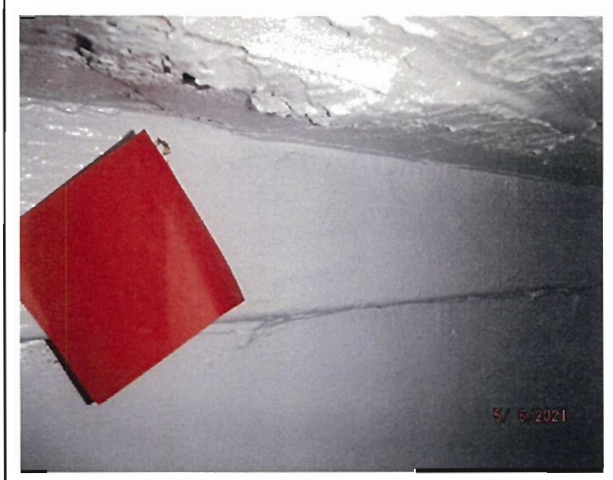
PHOTO # 6  
# 40 C,R Bath Shelf Support

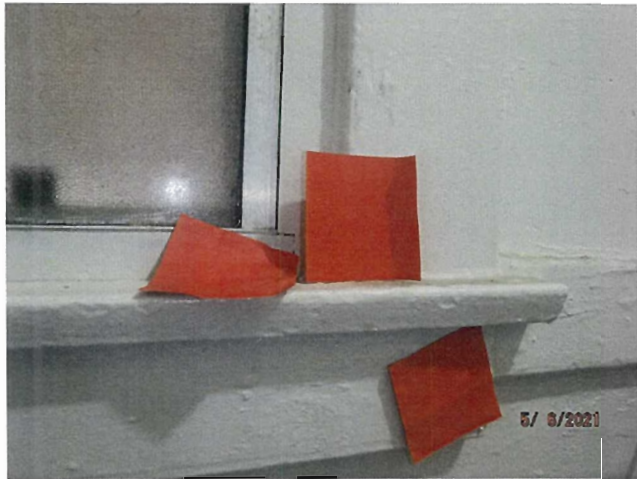
PHOTO # 7  
# 43, 44, 45 C,L Bath Window Components

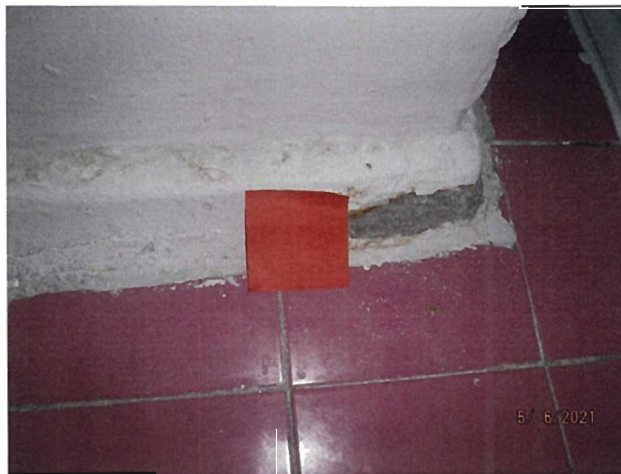
PHOTO # 8  
# 46 C,C Bath Baseboard

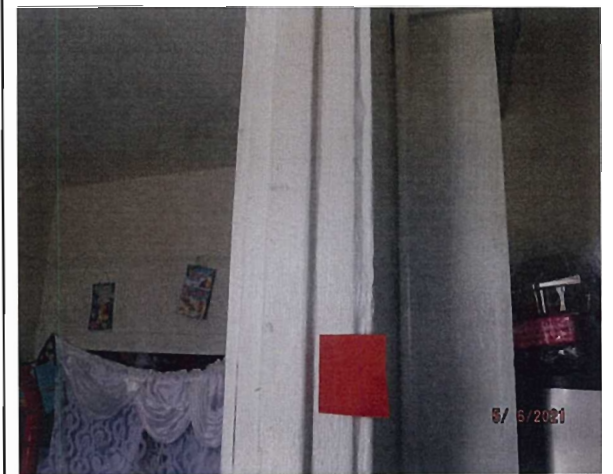
PHOTO # 9  
# 48 A,C Kitchen Door Jamb

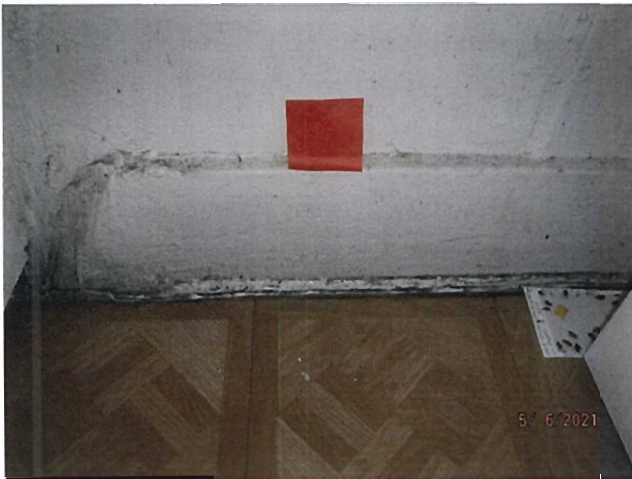
PHOTO # 10  
# 53 D,C Kitchen Baseboard

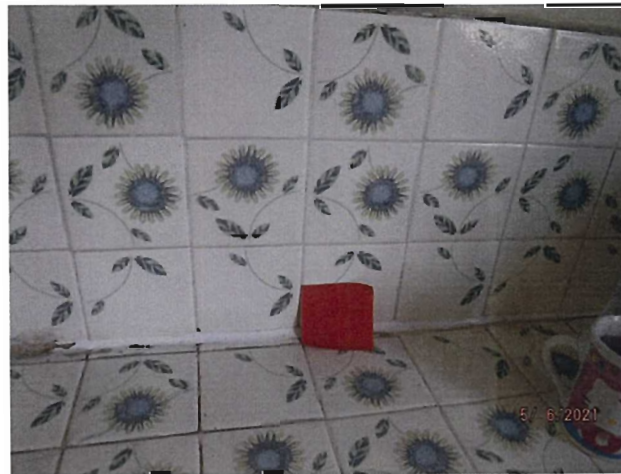
PHOTO # 11  
# 61, 62 Kitchen Tile Counter and Backsplash

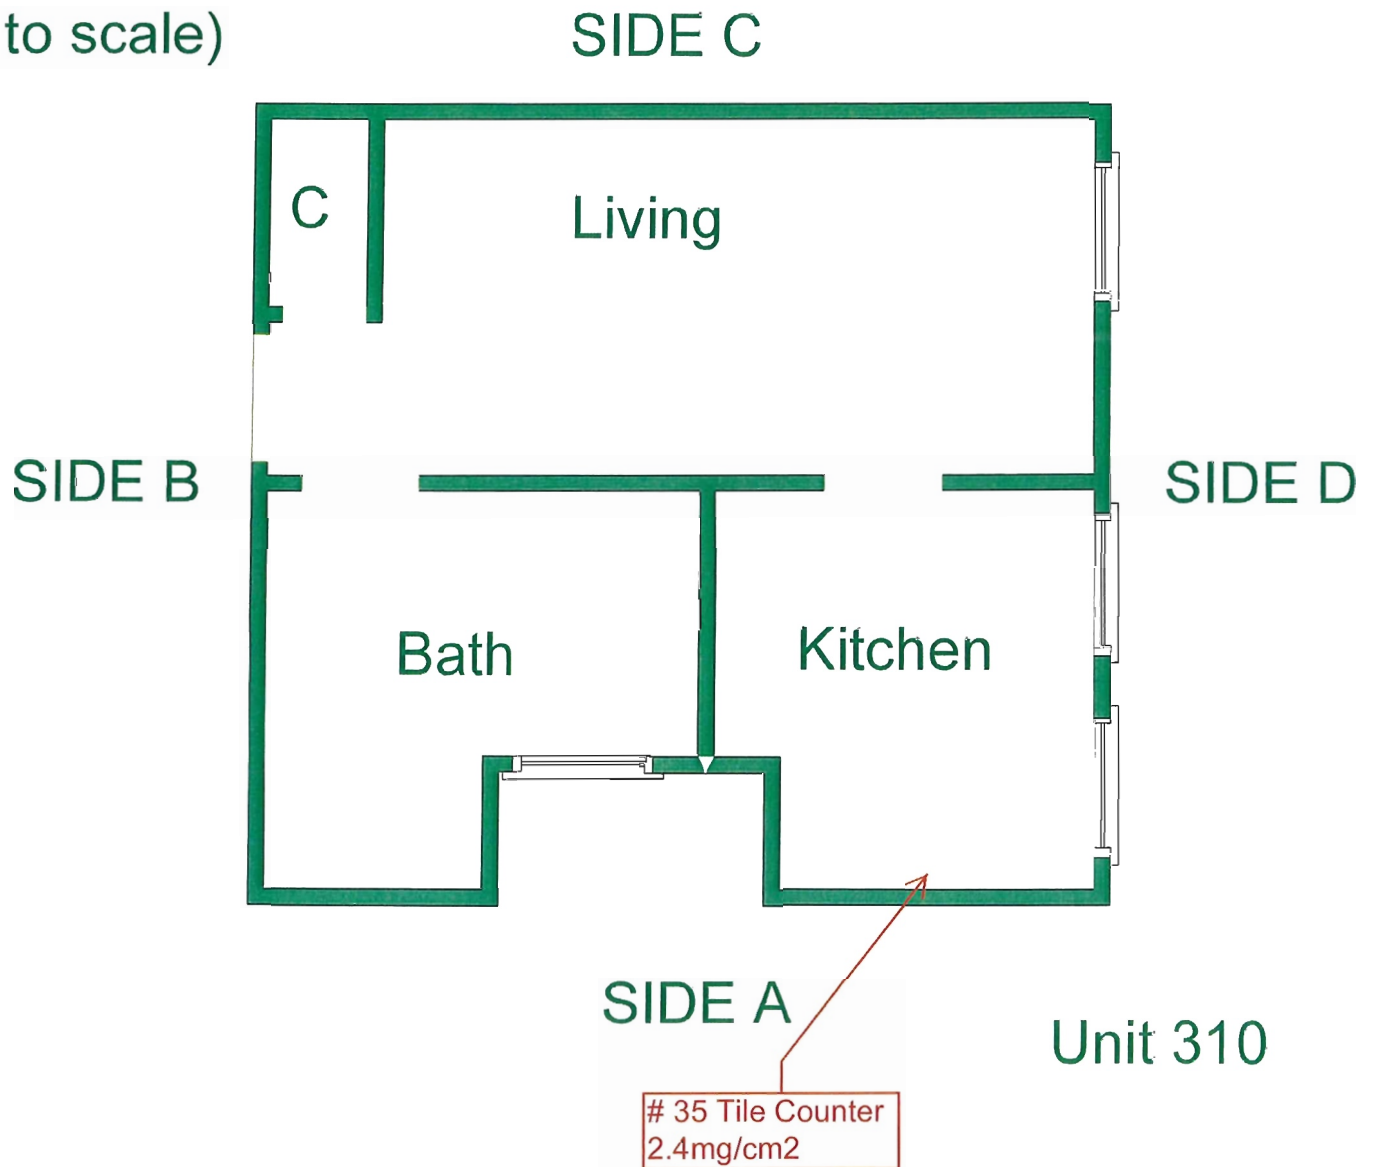
# Location Identified Contains Deteriorated Lead Tile

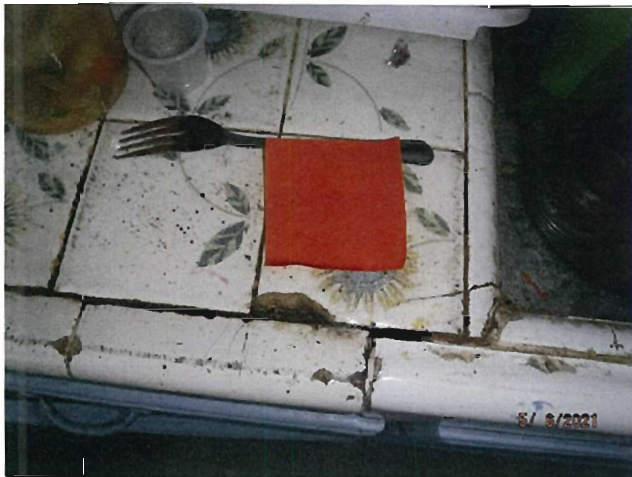
PHOTO # 1  
# 35 A,C Kitchen Counter Tile

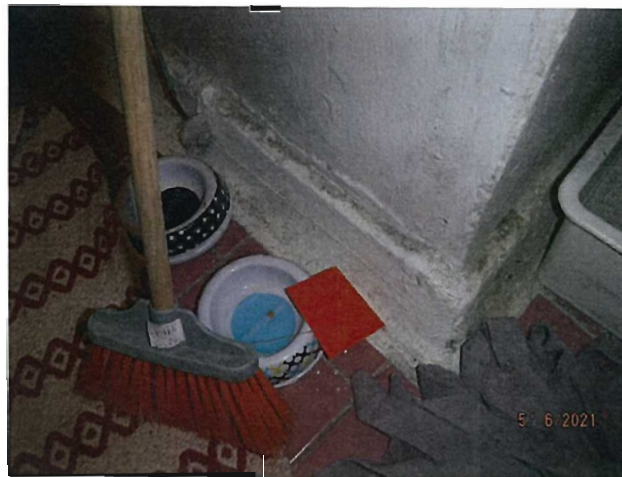
PHOTO # 2  
# 47 A,C Bath Baseboard
