# Locations Identified Contain Deteriorated Lead Based Paint On The A Side Of The Building

# PHOTOS OF COMPONENTS WHICH CONTAIN LEAD AT 300 EAST WASHINGTON BOULEVARD, LOS ANGELES, CA

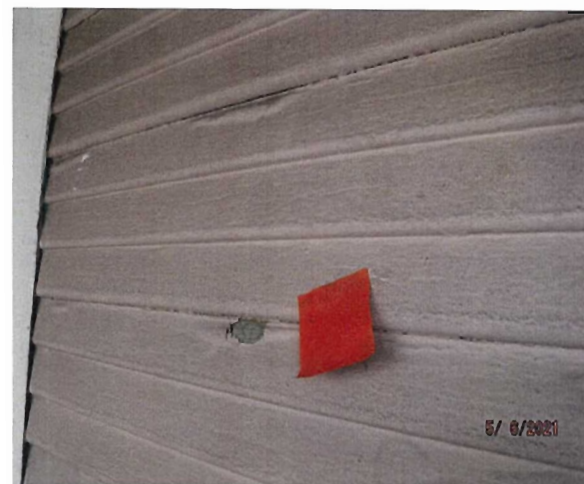
PHOTO # 21  
# 27 A,C Wood Wall

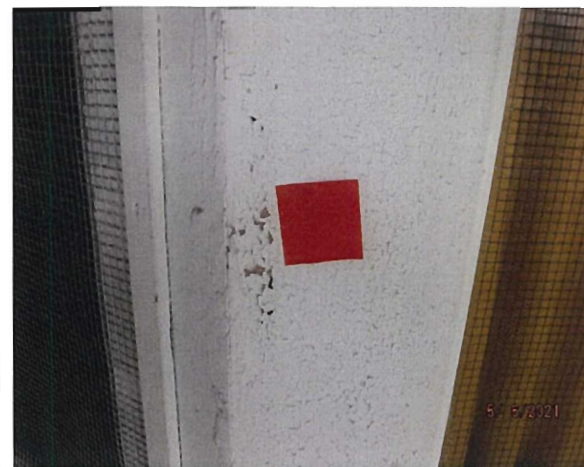
PHOTO # 24  
# 31 A,L Window Casing

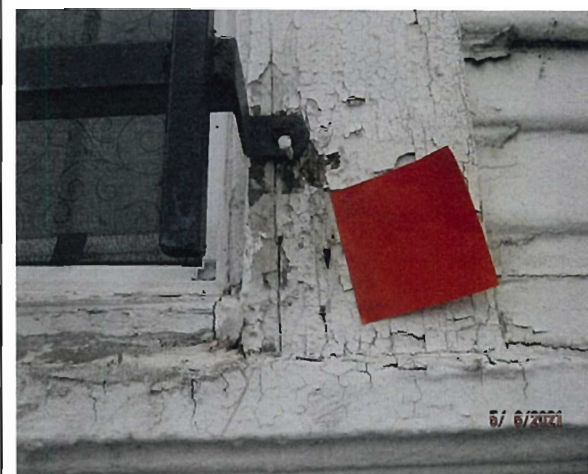
PHOTO # 33  
# 46 D,C Window Casing

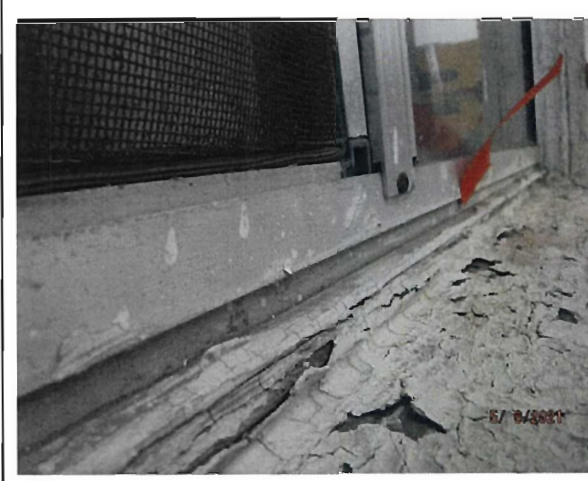
PHOTO # 36  
# 52 D,L Window Sill

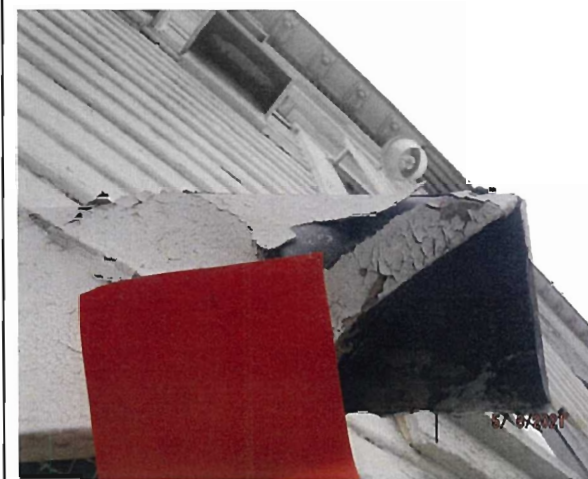
PHOTO # 39  
# 54 D,L Vent

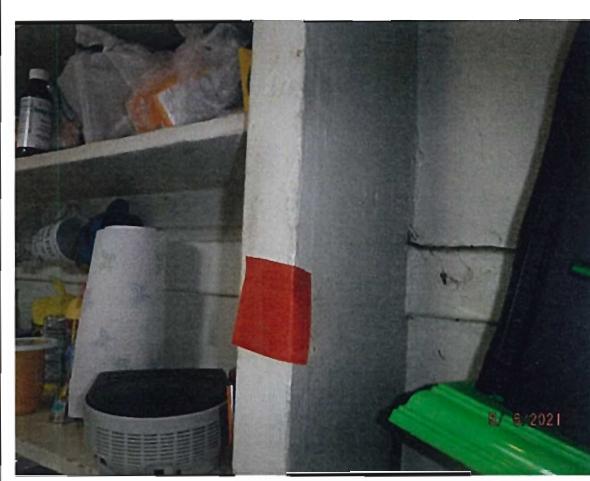
PHOTO # 6  
# 61 D,L Kitchen Cabinet Side

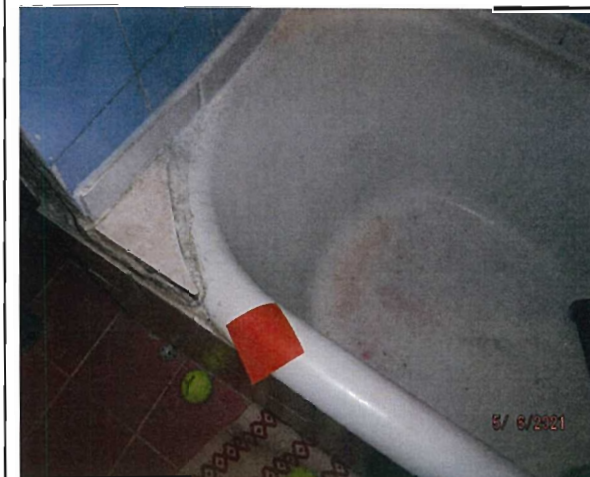
PHOTO # 3  
# 48 C,C Bath Bathtub
